DETECTING BUILDING DEFECTS WITH DEEP LEARNING

Abstract Building defects on external walls can include cracks, mould, dampness from waterproofing failures, fungus growth due to high humidity, and paint peeling. These building defects are commonly caused by wear and tear, improper maintenance, and weather conditions. The identification of these defects is very important to maintain the structural health and safety of buildings, which are often a large financial asset. Manual visual inspection is a traditional technique for defect detection and the most laborious way to identify wear defects, in addition to other nondestructive testing procedures that determine defect properties. Advances in DL and computer vision are expected to improve the efficiency of defect detection. For instance, the DL-based YOLOv10 (You Only Look Once) method provides real-time defect detection that is fast and accurate. This study provided the YOLOv10 technique for the automated detection and localization of building defects. In addition, this study not only makes defect detection more efficient but also helps researchers to advance the overall inspection process with more efficiency.

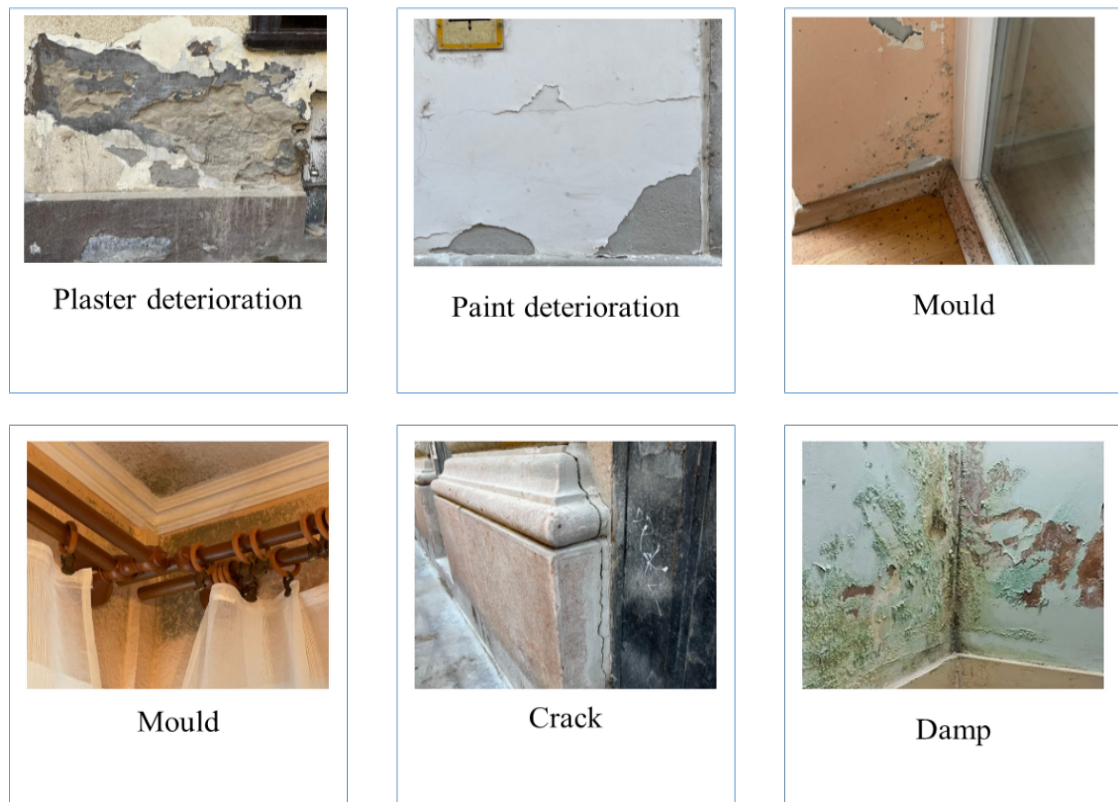
and Low, 2006 [5]). Weather related factors include sunlight, rain, wind, and humidity. When humidity moves from wet areas to dry areas, it can lead to the growth of algae and fungus. Low quality building materials are often damaged by destruction and accidents, and sometimes materials deteriorate faster than expected. Poor design frequently causes issues from loads and residential. Geological problems, such as cracks from soil settlement, can be particularly dangerous. In a study by (Chong and Low, 2006 [5]), these factors were investigated. The authors examined 74 buildings over nine months and found that moisture from damp areas, weather, low material quality, and usage were the primary factors. The study concluded that these defects could be potentially avoided by using better materials, implementing damage prevention measures, treating water leakage, improving design details and conducting thorough site assessments. In addition, many studies have identified the common defects in buildings, such as reinforced corrosion from chemical reactions within the concrete, which reduces the durability of beams and pillars. Roof leakage, caused by water pressure and poor concrete filling. Cement oozing, or salt staining, results from poor construction and an improper mixture of concrete. Cracks and popping in tiles are due to adhesive failure. Wall cracks can occur due to vibrations from the metal support system for the air conditioning system. Exposed metal installations are sensitive to rapid corrosion due to environmental factors. Lastly, a lack of construction knowledge and maintenance expertise plays a major role in building defects (Kian, 2001 [21]) (Marshall et al., 2009 [28]). It is also considered a building defect when weed plants, vines, moss, or roots start growing from cracks in the wall due to dampness which damages the building facade. The plant's roots penetrate the wall, causing further cracks and deterioration, which can lead to serious structural damage. Such defects are presented in Figure 1.

Figure 1: Examples of building defects.

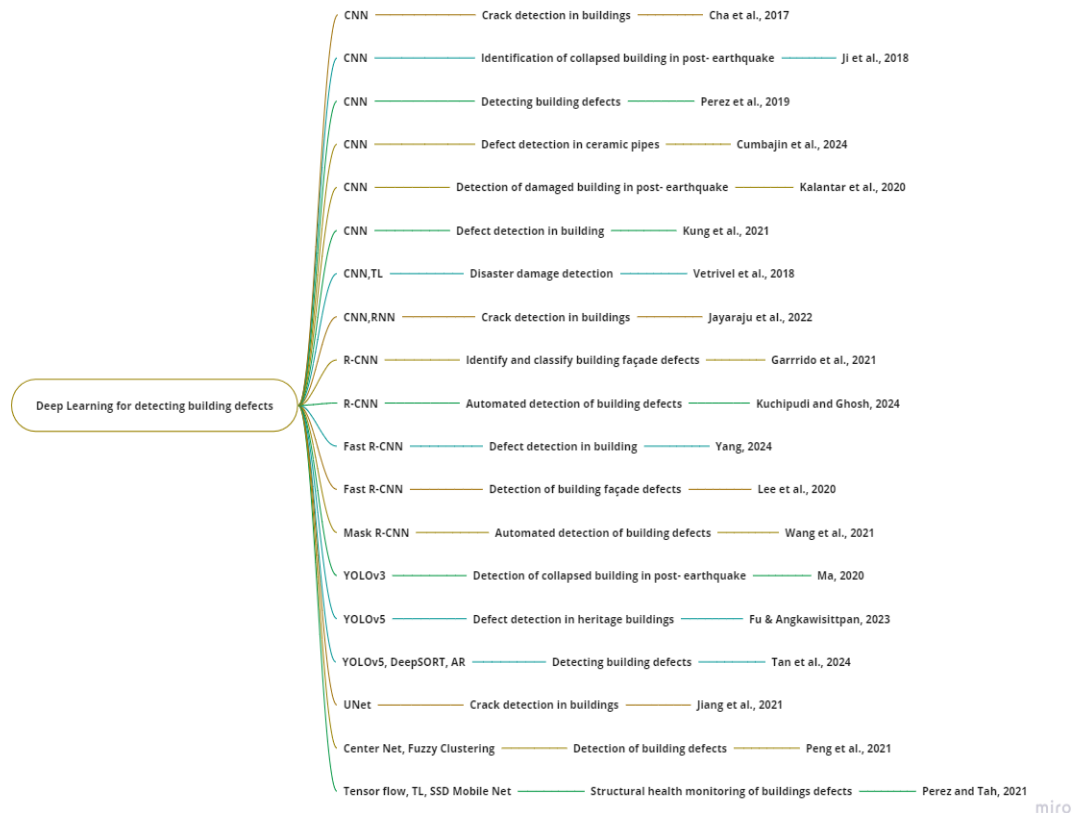
Figure 2: Taxonomy of DL methods for detecting building defects.

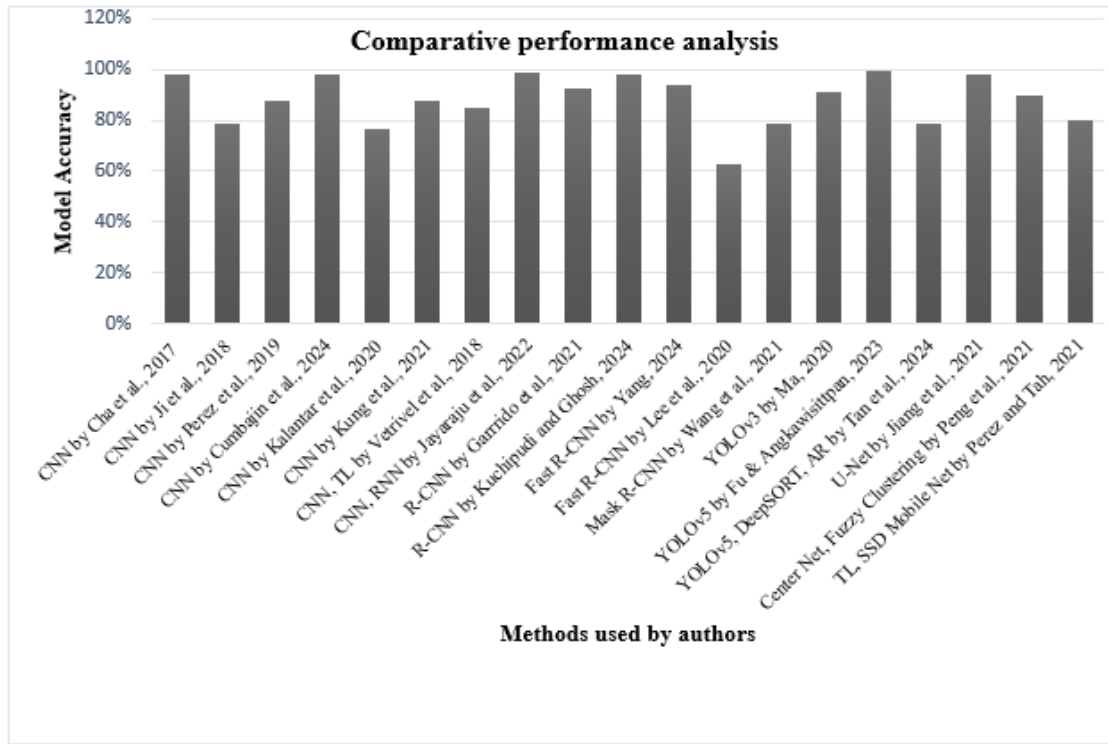
Angkawisittpan, 2023 [12]) to automatically detect the surface defects of heritage buildings. A total 2400 images with 512×512 pixels of moss, cracking, alkalization, staining, and deterioration defects are used. The YOLOv5 model is used for classifying and detecting only plant penetration defects. Whereas, the Swin Transformer is used for image segmentation and detecting other defects like cracking, alkalization, staining, deterioration, and moss. The Swin Transformer achieved 95.78% accuracy while YOLOv5 model achieved highest accuracy of 99.2%. In addition, (Tan et al., 2024 [39]) developed an AR-based defect inspection application using YOLOv5 and DeepSORT algorithms for real-time defect detection and tracking. The proposed system combines computer vision, AR, and building information modeling (BIM) to improve the defect inspection process. To develop the model, a dataset of 7,430 images with a resolution of 2532×1170 pixels is utilized. AR-based method achieved an accuracy of 78.63%. (Jiang et al., 2021 [19]) presented an efficient method for defect detection and visualization of buildings using DL based method. The 3D photos are collected using drones and cameras. The U-Net method is used for image segmentation to detect and localize the defect. The developed model achieved an overall accuracy of 97.82%. Building façade and its falling is very common building deterioration defect. For this (Peng et al., 2021 [32]) proposed a DL based method to identify debonding defect. An UAVs based thermography detection method is integrated with Center point network and fuzzy clustering to quantify and recognize such defects. A dataset of 1000 images with 640×480 pixels is utilized. The proposed model performed accurately and achieved an accuracy of above 90%. (Perez and Tah, 2021 [33]) developed a DL based model to detect the building defects which can be used to assess the condition and health of buildings. The 875 images of building defects such as cracks, mould, stain and paint deterioration are collected for the dataset. Data augmentation technique is used to improve the dataset. VGG image annotator is used to annotate the images. Tensor Flow model is integrated with single-shot multibox detection (SSD) Mobile Nets to detect the defect using mobile phone. This developed real time defect detector performed well and achieved 80% accuracy. After discussing and presenting a brief review of the most used DL methods, a taxonomy categorizing these methods based on their respective authors can be seen in Figure 2. This can provide a clear overview of the different DL methods and their contributions of building defect detection. Considering the above-mentioned DL methods for the application of detecting building defects, it is apparent that CNNs, R-CNN, Mask R-CNN, Faster R-CNN, RNN, TL, YOLO and other ensemble methods are the most popular. Here, it is worth mentioning that the value of accuracy can be different across studies. In addition, the values of accuracy in some studies were calculated for different methods. To ensure a fair comparison of the DL methods, we standardized the accuracy percentage and calculated the average when there were multiple accuracy values are reported. Any possible error is cross checked. The comparative performance analysis of DL methods for detecting building defects using percentage of model accuracy are presented in Figure 3.

Figure 3: Comparative performance analysis of DL methods for detecting building defects.

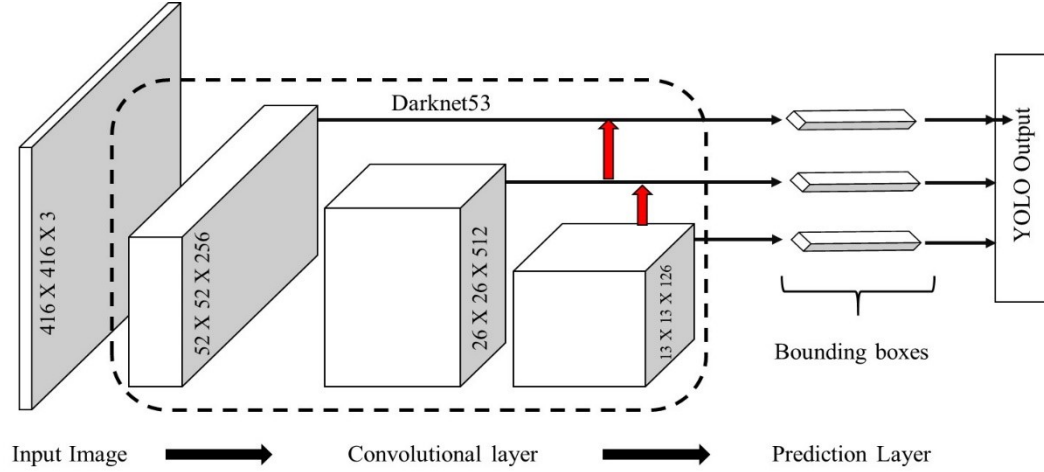
Figure 4: Schematic representation of the YOLOv3 model, with red arrows indicating the process of up-sampling performed twice.

The YOLOv3 network structure, as presented in the study by (Ma et al., 2020 [26]). The process starts with resizing the input image to 416×416×3 pixels. After feature extraction using Darknet53, the image is transformed into a 13×13×126 feature map. Additionally, two more feature maps of size 26×26×512 and 52×52×256 are created. The detection occurs at three different scales. The feature map being up-sampled two times to merge the information across scales. This up sampling helps to provide more accurate detections. Each cell predicts three bounding boxes using anchor boxes, and the best-fitting box is selected. The network predicts the center (XY), width and height (WH), score of confidence, and category of object for each bounding box. The final output is based on the set of predicted bounding boxes and class labels for each object in the image. The YOLO series performs well in balancing speed and accuracy, making it ideal choice for such applications. For example, (Zhang et al., 2022) employed the ResNet18-YOLOv2 model with GPR for automatic void detection on airport runways. (Zhang et al., 2020) utilized YOLOv3 to detect various types of concrete damage in highway bridges. (Yu et al., 2021) developed a YOLOv4 model for UAV-based crack detection on bridges, using focal loss to improve the detection accuracy. (Zhao et al.,

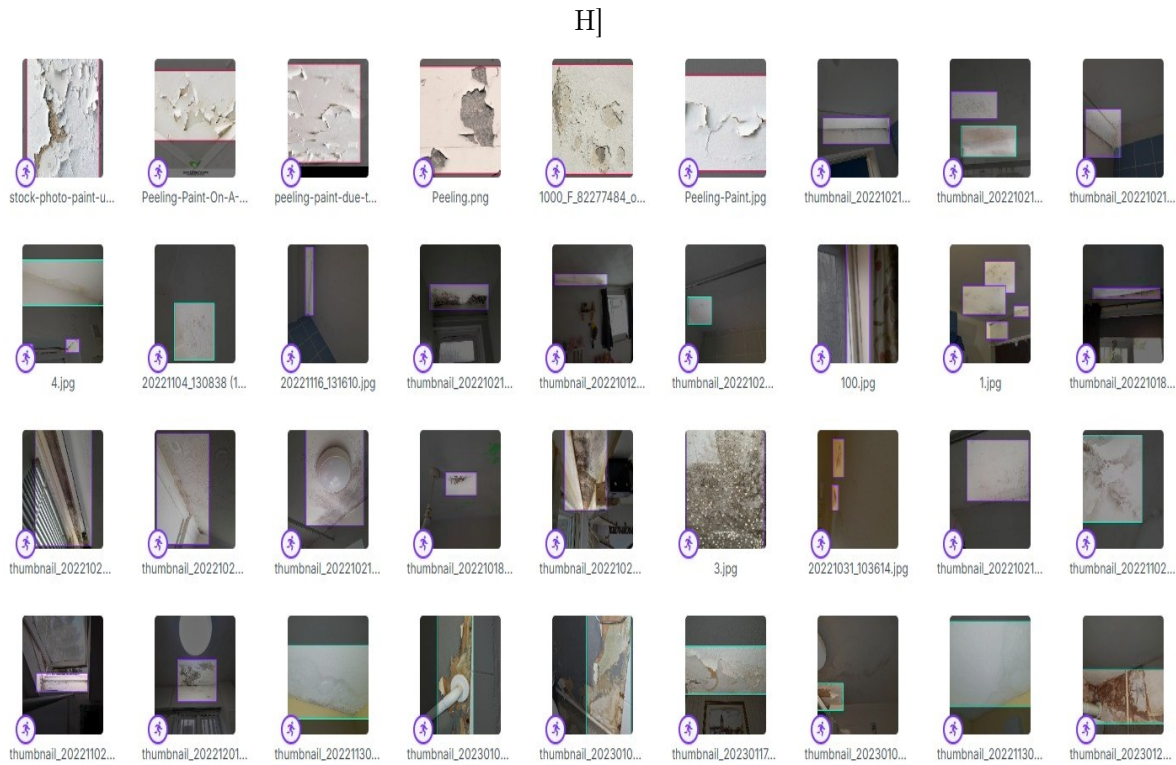
Figure 5: A sample of dataset used to train the model.

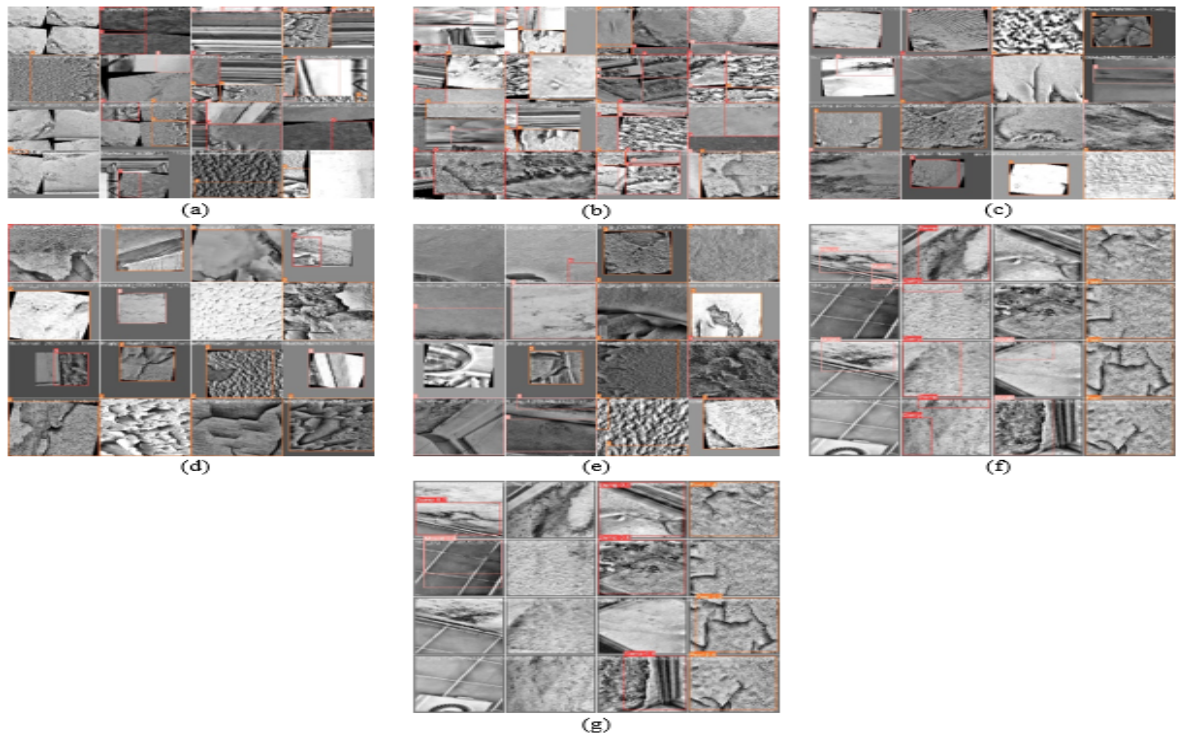
Figure 6. displays the examples of correctly classified defects. The images in this figure illustrate cases where the model successfully predicted the correct class for damp, mould, and

Figure 6: (a) (b) (c) (d) (e) (f) & (g) are the examples of the correct classification.

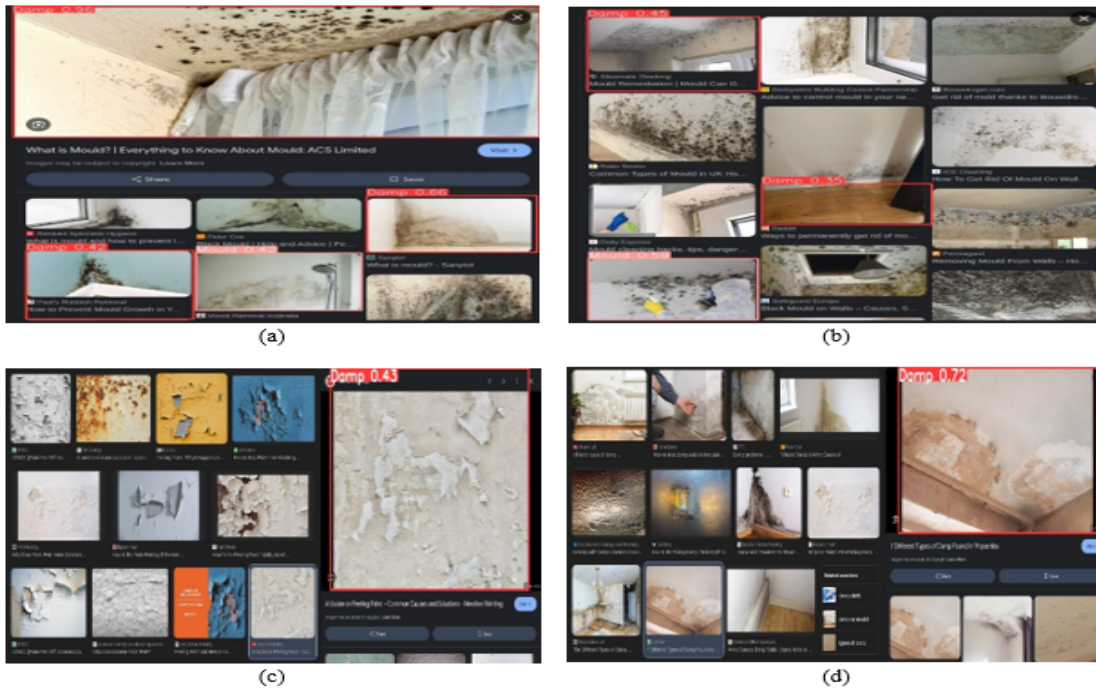
peeling, respectively. Whereas, Figure 7. shows the examples of defects classification errors. The images in this figure demonstrate different cases where the model failed to predict the correct class. As demonstrated YOLOv10 works well in spotting building defects, but its performance depends on the type of defect. Since mould was more common in the dataset, the model learned to detect it more accurately than damp or peeling paint. The plots also suggest that while some defects share similar features, mould stands out more clearly, which explains the stronger results. The confidence curves reveal that the model is precise, but it sometimes misses damp and peeling defects, especially when they are less obvious. The precision-recall curve backs this up, which shows mould as the most reliably detected class. Overall, the model handles clear and well-defined defects well, but to improve detection of subtle ones, we'll need more balanced training data and smarter ways of teaching the model to pick up on fine details.

Figure 7: (a) (b) (c) & (d) are the examples of the classification errors.

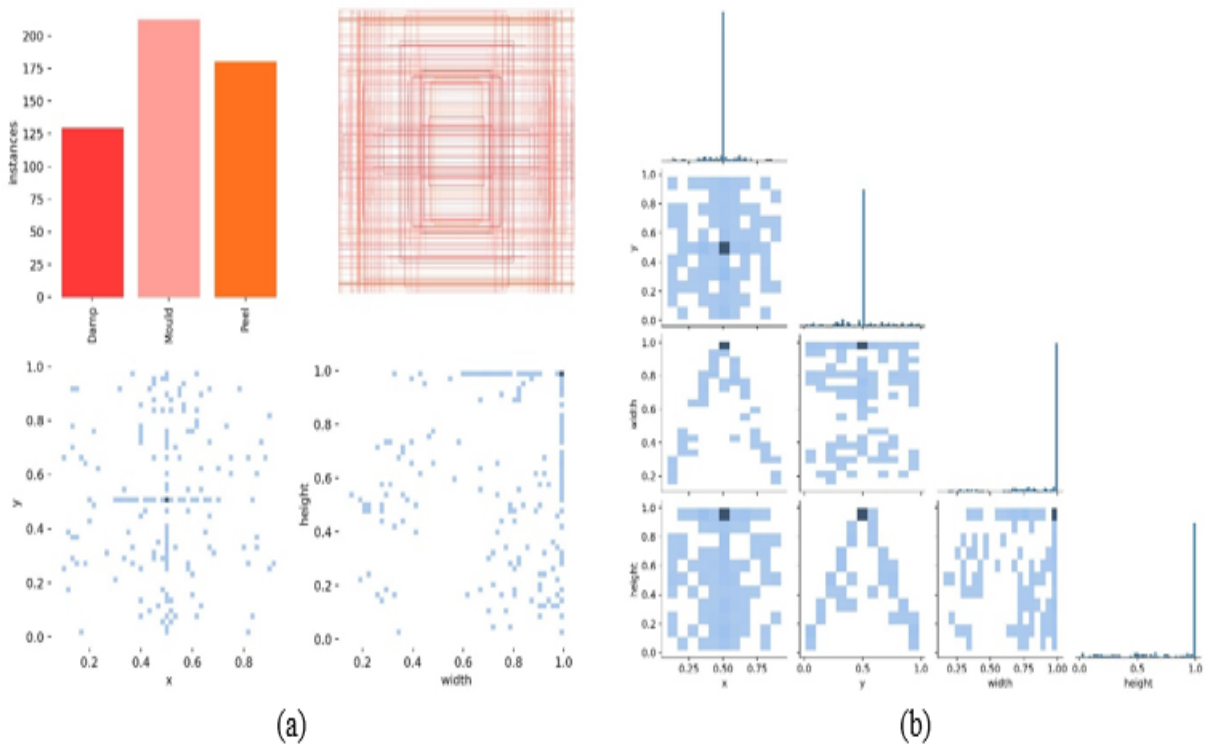
Figure 8: (a) Visualization of Class Labels (b) Correlation Between Class Labels

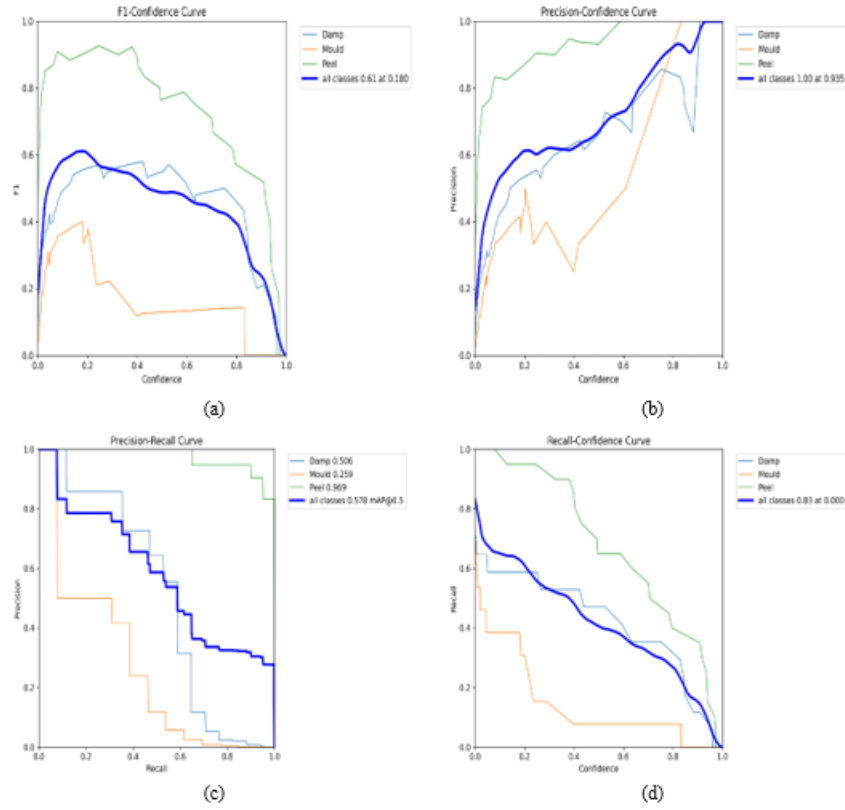
Figure 9: (a) F1-Confidence Curve, (b) Precision-Confidence Curve, (c) Precision-Recall Curve, (d) Recall-Confidence Curve.

confidence and F1-confidence curves indicate that the model maintains strong precision even at higher confidence thresholds, but recall drops for harder classes like peeling. The precision-recall analysis confirms this trade-off, with mould reaching the best balance while damp lags behind. Overall, the model demonstrates that real-time automated detection of defects is feasible, though improving recall for subtle defects will require more diverse training data or additional feature cues.

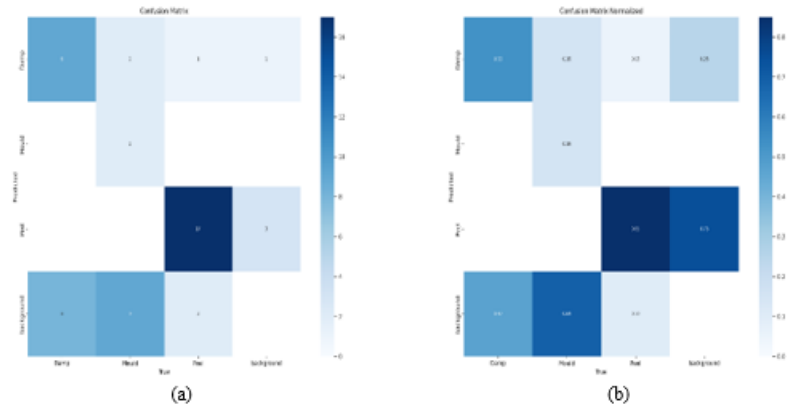
Figure 10: (a) Confusion Matrix, (b) Normalized Confusion Matrix

Our results show that the YOLOv10 model can detect building defects with promising accuracy, but performance varies across defect types. The confusion matrices highlight that mould was detected with high precision and recall, while damp and peeling paint showed more misclassifications, which suggests visual overlap or dataset imbalance. The precision-
